This thesis entitled "Post-Impact Fatigue of Cross-Plied, Through-the-Thickness Reinforced Carbon/Epoxy Composites" and written by Thomas E. Serdinak is presented to the Graduate School of Clemson University. I recommend that it be accepted in partial fulfillment of the requirements for the degree of Master of Science with a major in Engineering Mechanics.

(NASA-TM-110625) POST-IMPACT
FATIGUE OF CROSS-PLIED,
THROUGH-THE-THICKNESS REINFORCED
CARBON/EPOXY COMPOSITES M.S. Thesis
- Clemson Univ. (NASA Langley
Research Center) 176 p

UTTL: Post-impact fatigue of cross-ply, through-the-thickness reinforced
carbon/epoxy composites TLSP: M.S. Thesis - Clemson Univ.

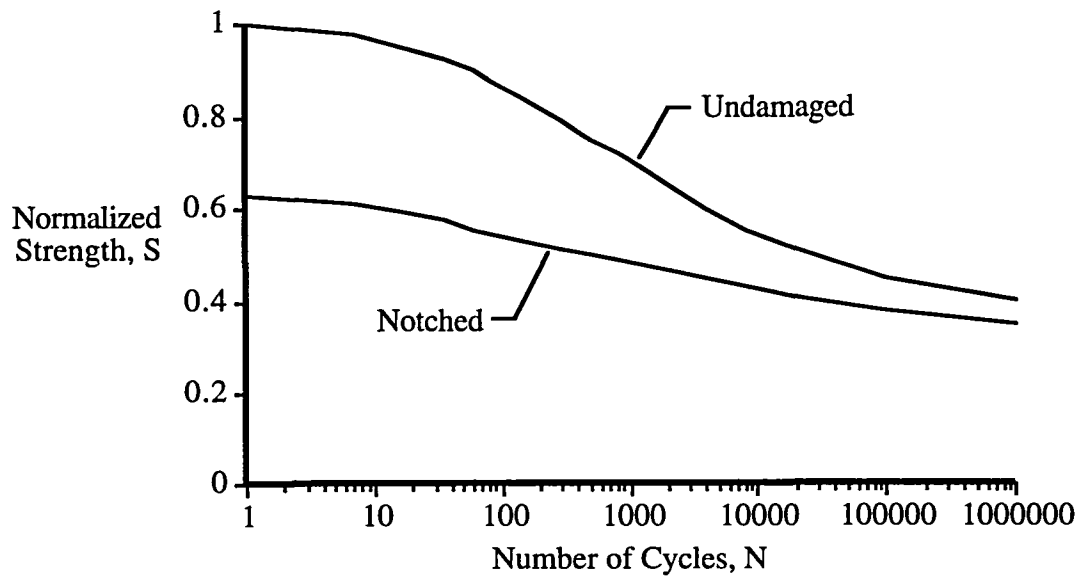
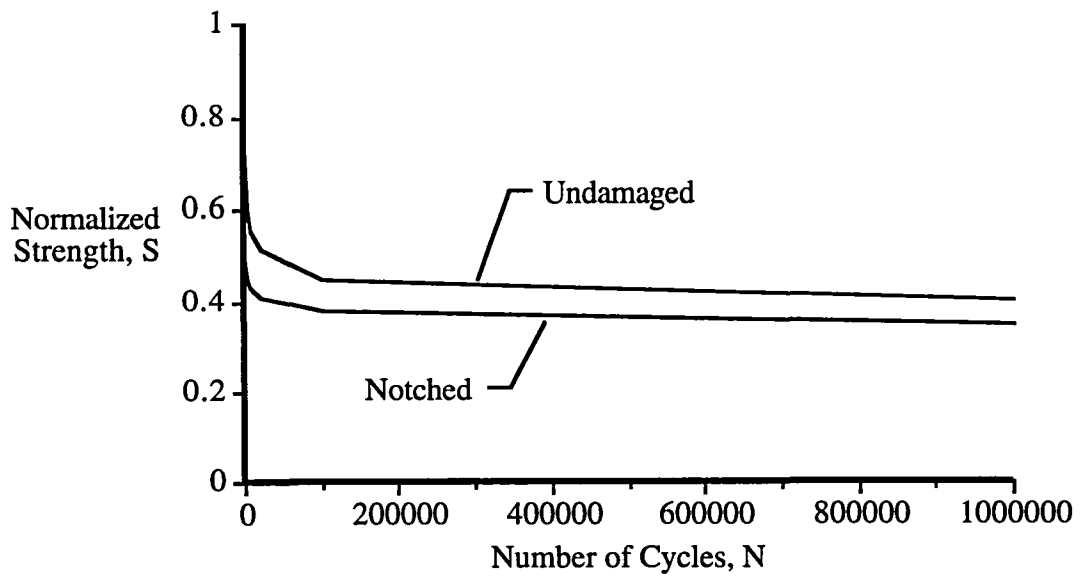
Figure 1. Typical S-N curves for undamaged and notched laminates.

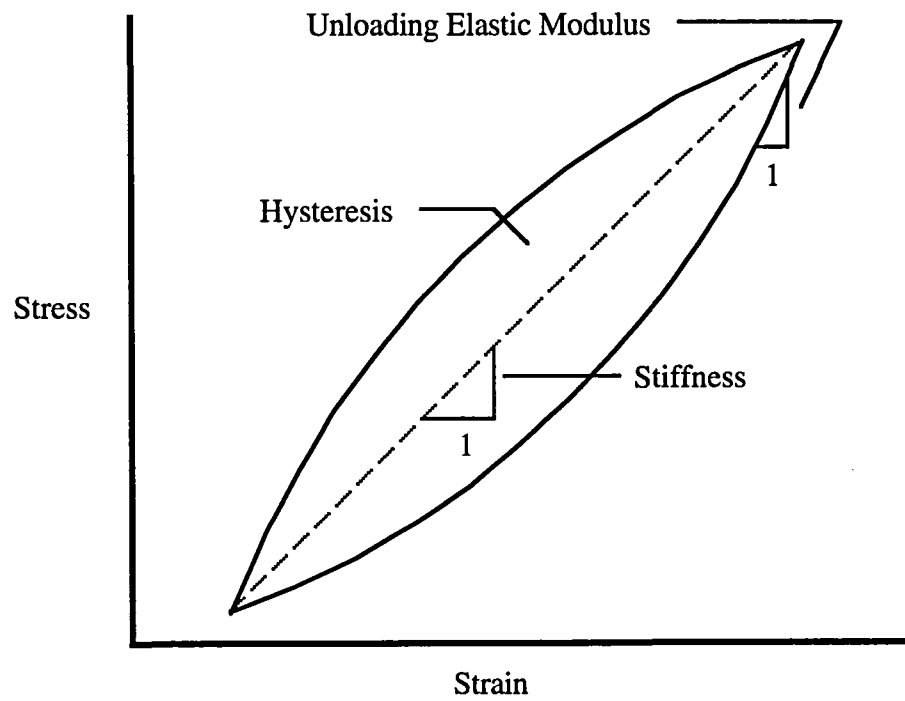
Figure 2. Stress versus strain for one cycle in a fatigue test.

changes in a laminate [35]. Consequently, Johnson [38] introduced the unloading elastic modulus as a more direct indicator of fatigue damage.

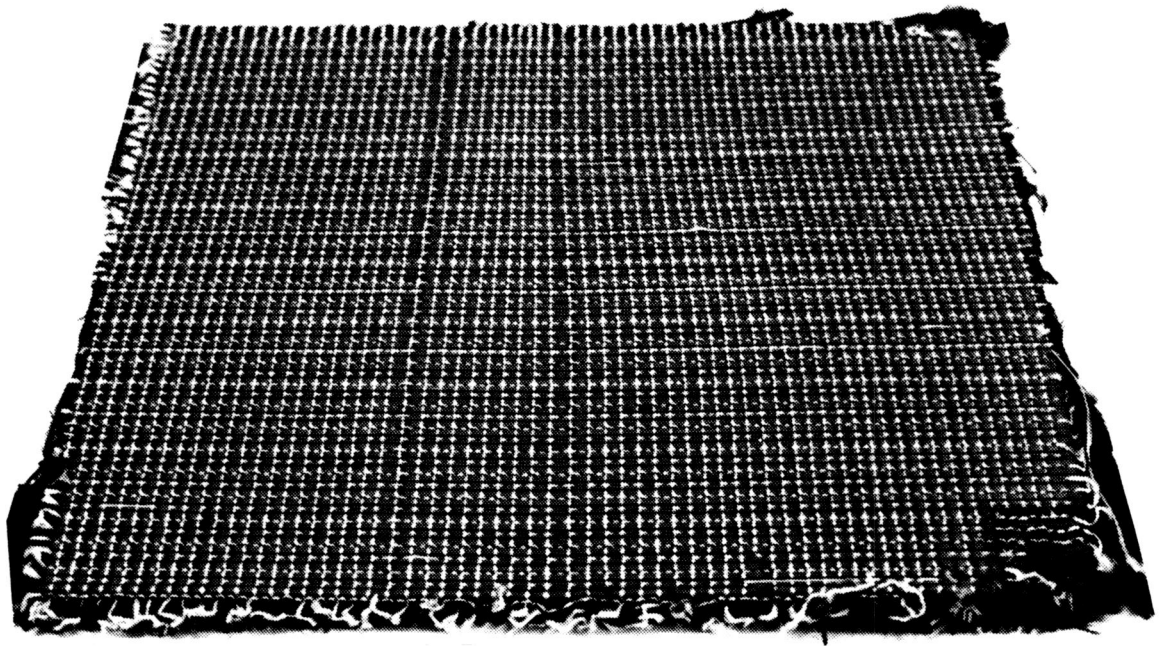
Figure 4. Integrally woven preform (Kevlar TTT reinforcement).

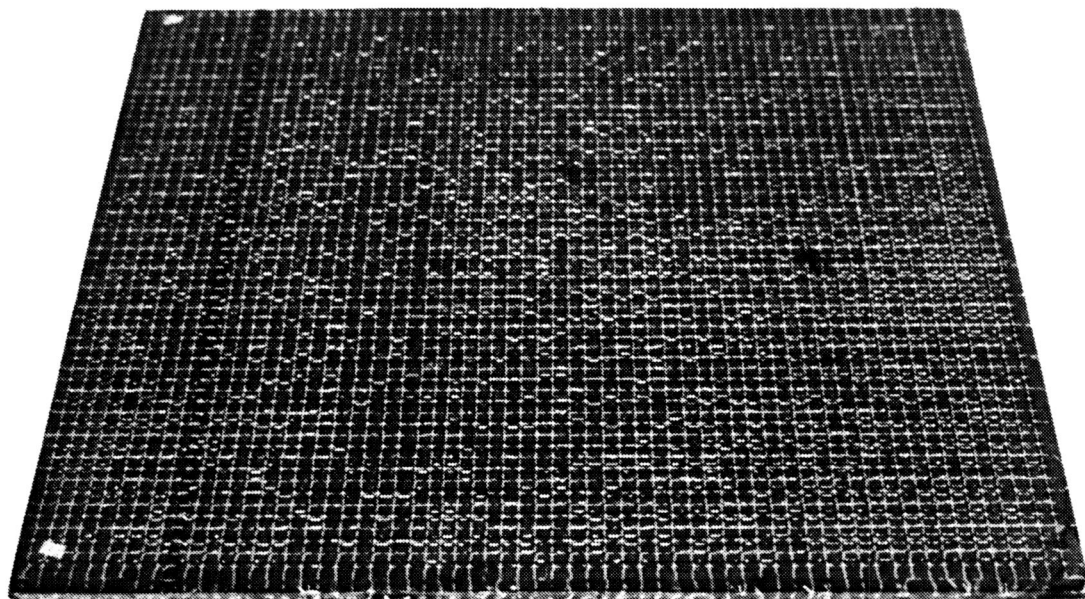
Figure 5. Integrally woven carbon/epoxy 16" by 14" composite panel (Kevlar TTT reinforcement).

The composite panels were produced in sixteen by fourteen inch panels, as shown in Figure 5. The panels were cut into four inch wide by sixteen inch long samples with a diamond tipped circular saw blade. The edges were cut parallel to the TTT reinforcement surface loops on the top zero degree ply.

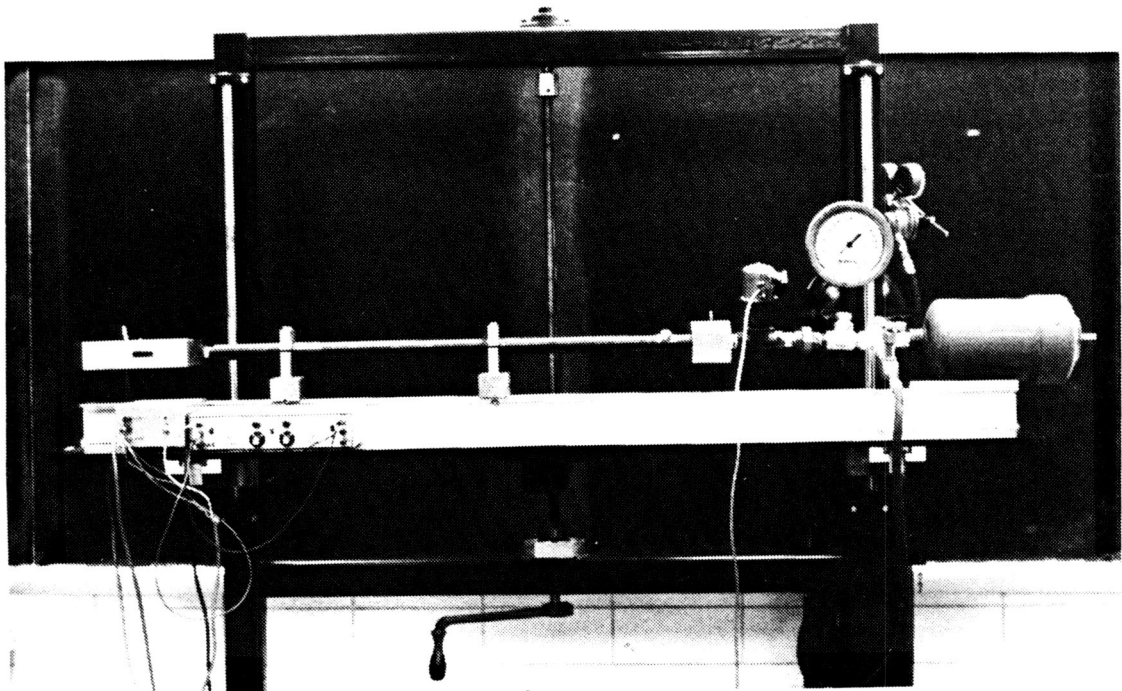
Figure 6. Impact device.

Each sample was impacted at the geometric center. The average velocity was 543.4 ft/sec with a standard deviation of 7.3 ft/sec. During impact, the ends of each sample were held in place with the hydraulic grips of the testing machine. Approximately ten inches of each sample was unconstrained, and the front face of each sample was approximately one

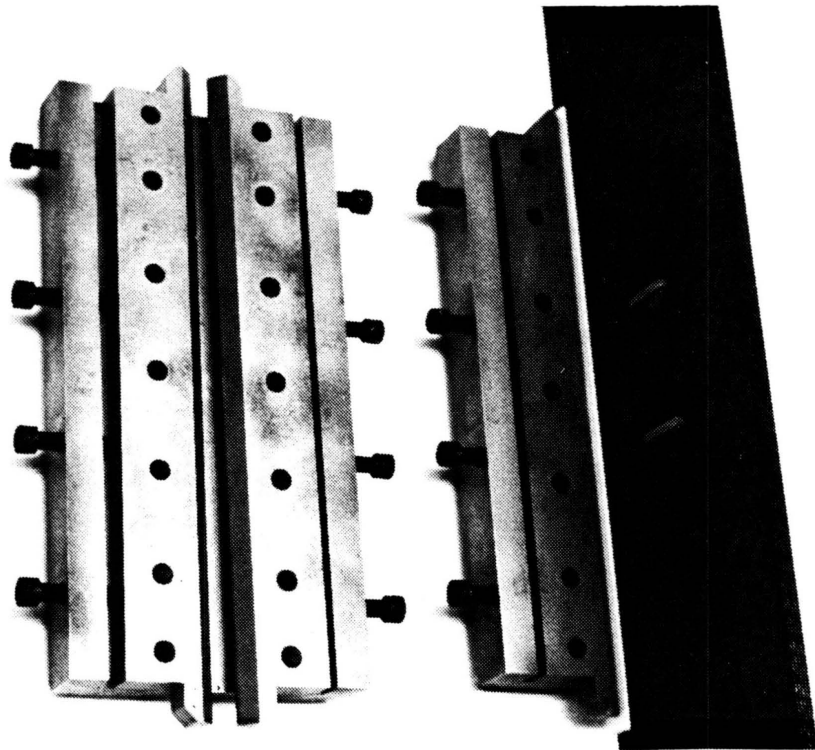
Figure 7. Side supports.

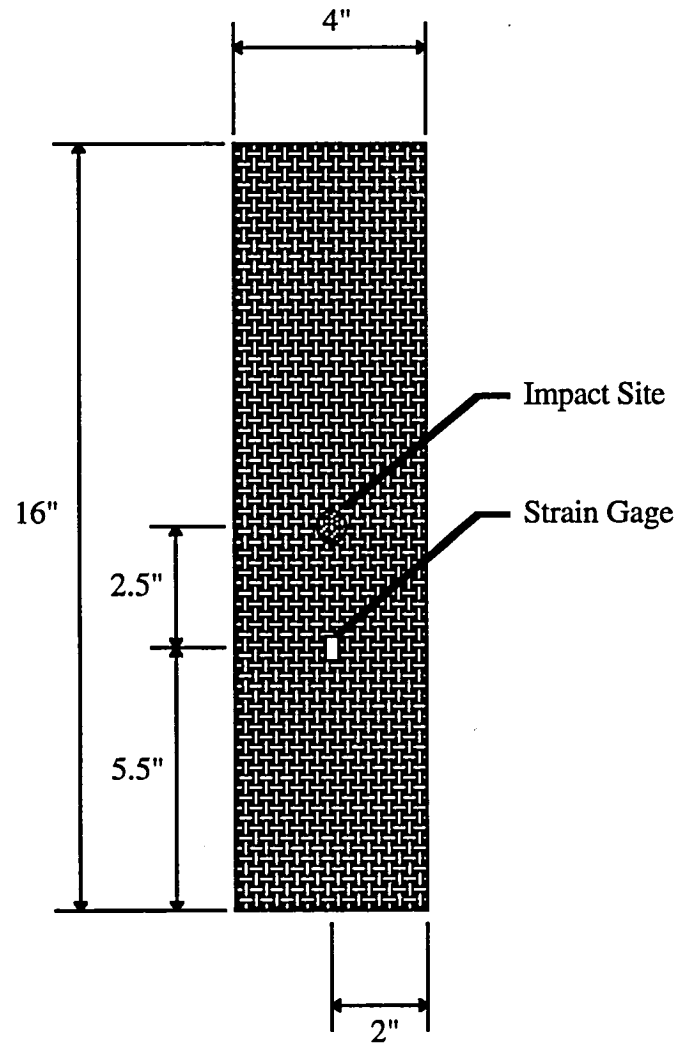
Figure 8. Location of strain gages on static compression samples.

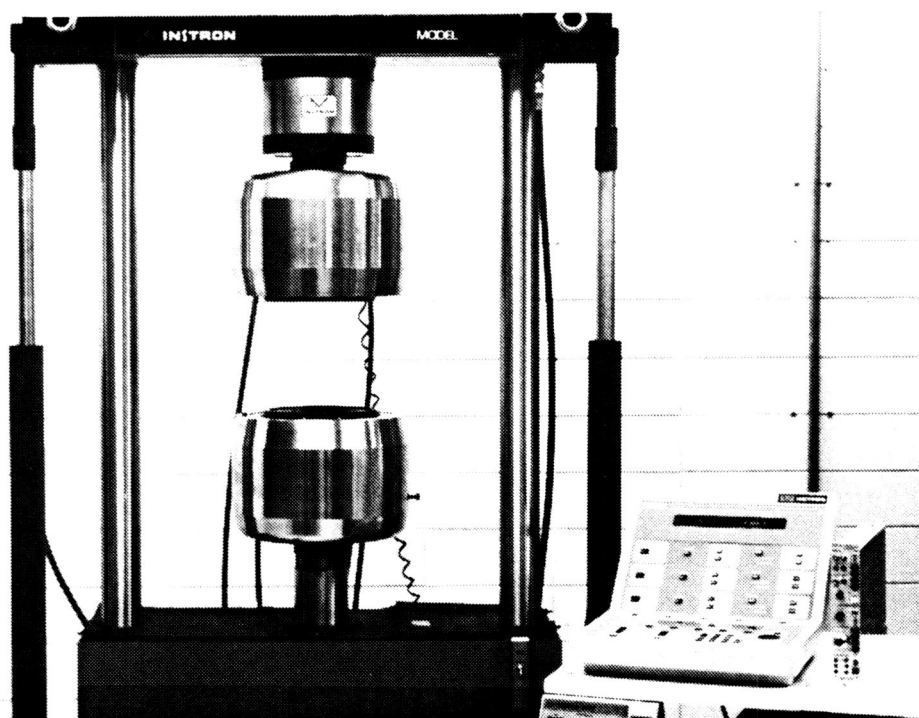
Figure 9. Instron load frame and electronic controller.

Compression tests were conducted on the 56 kip servo-hydraulic Instron 1332 load frame with an Instron 8500 series electronic controller shown in Figure 9. Hydraulic grips were used to exert pressure on four inch by three inch aluminum tabs which were mounted to the ends of each sample. The grip pressure was set at 3000 psi. The samples were tested to failure under load control at a rate of 5.0 kips/min., which produced a corresponding strain rate of approximately 0.0005 per minute.

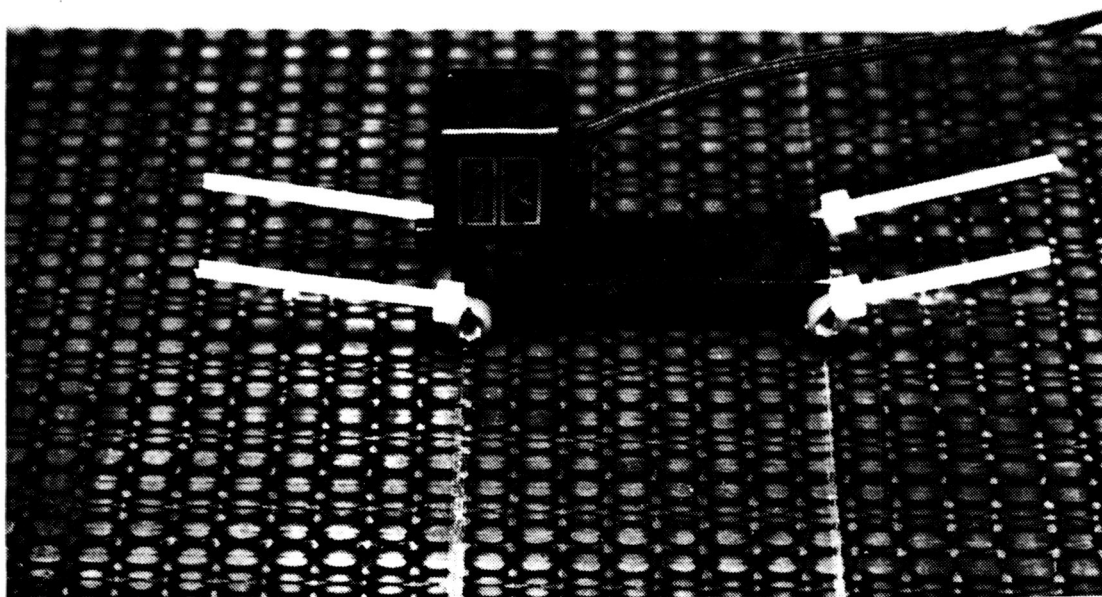
Figure 12. Extensometer attached to tabs mounted across impact site on sample.

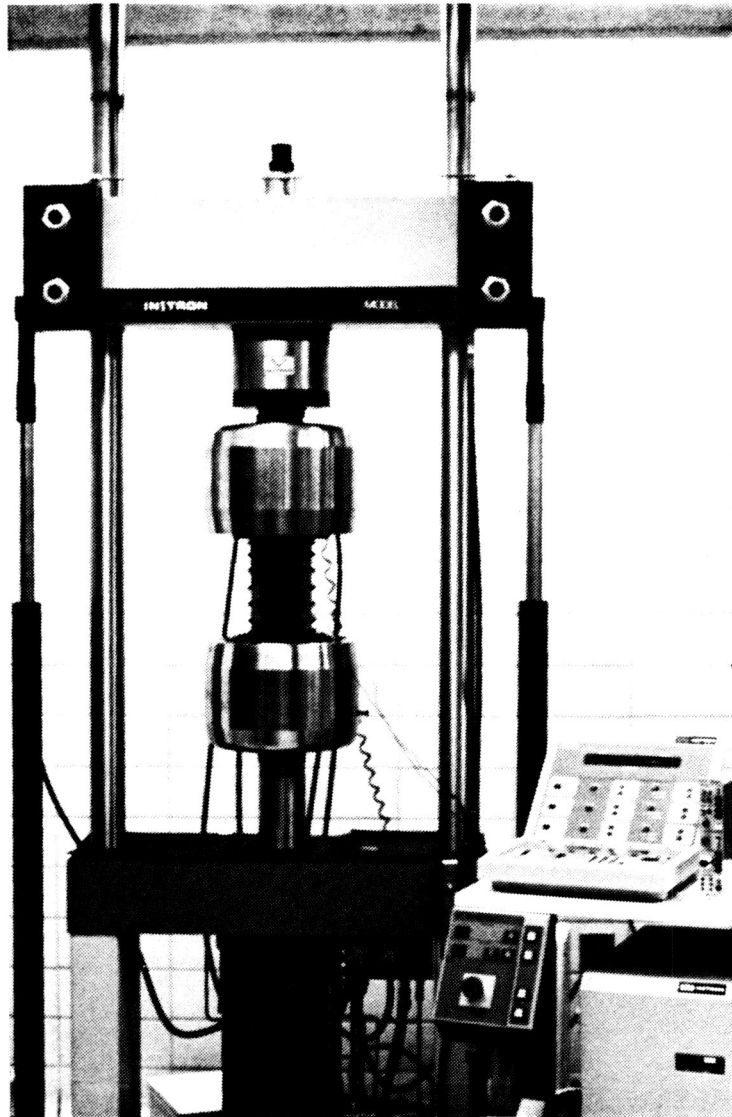
Figure 13. Instron load frame and electronic controller with sample mounted for fatigue test.

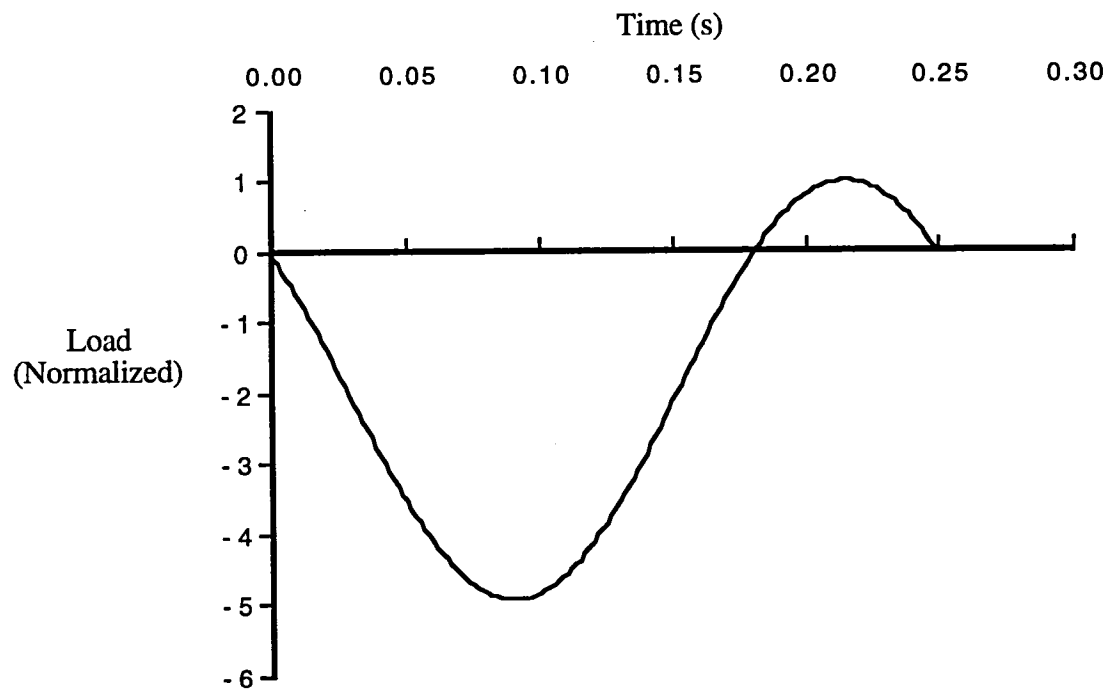
Figure 14. Load cycle for fatigue tests ($R = -5.0$, frequency = 4 Hz).

The loading wave form was sinusoidal, as shown in Figure 14, with a loading ratio $R = -5$. Each sample was tested at a frequency of 4 Hz. The maximum compressive load for each sample was chosen as a percentage of the static compressive strength for each

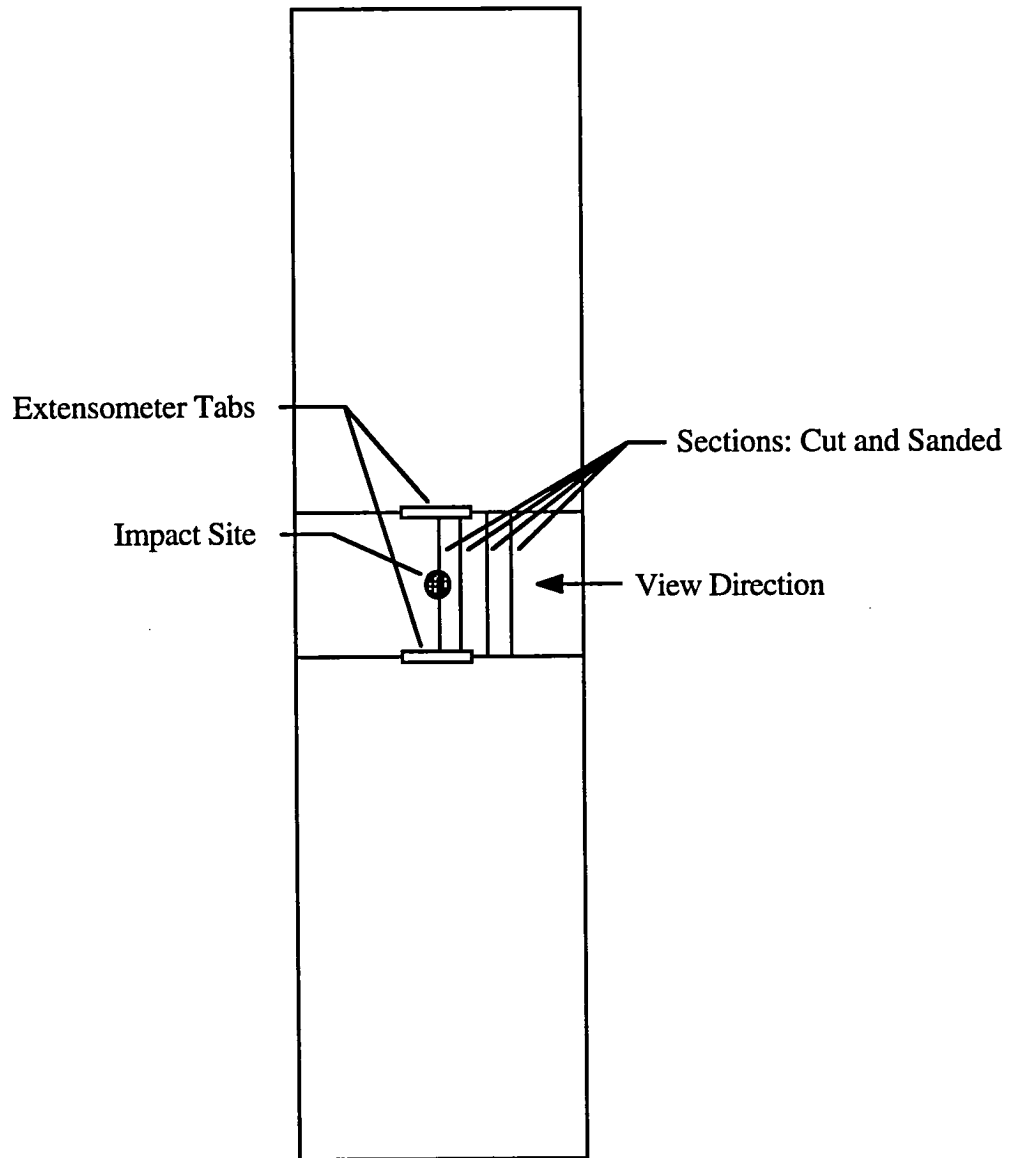
Figure 15. Location of sectioning cuts.

Ten samples were sectioned to evaluate impact and fatigue damage. The five samples (one from each material group) fatigued nearly to failure, which were radiographed, were cross-sectioned. Five impacted samples (one from each material group), with no static or fatigue loading, were also evaluated. Each sample was cut parallel to its sides, as shown in Figure 15, and wet-sanded with 240, 320, 400, and 600 grit paper. The samples were then photographed and examined under a microscope.

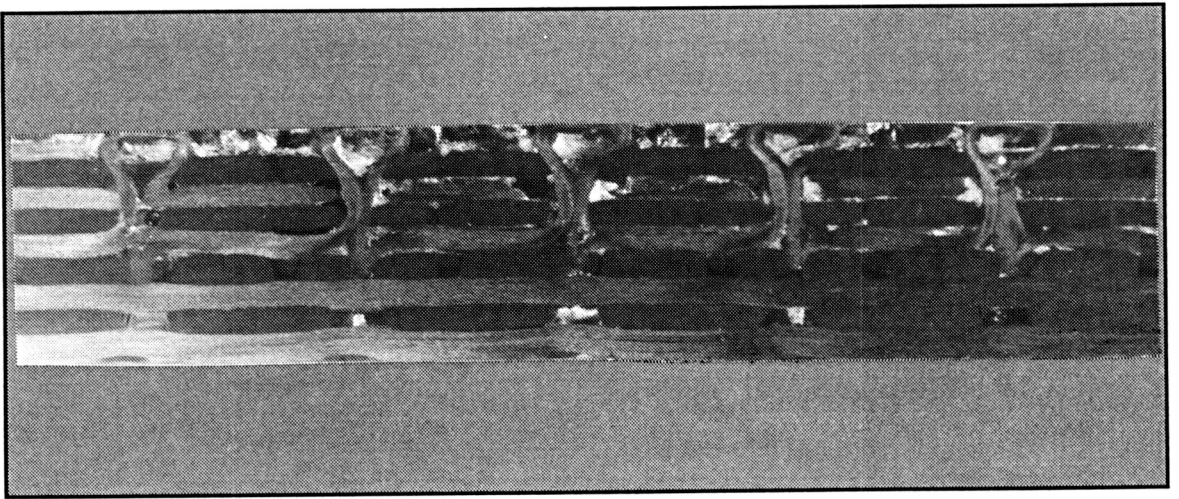
Figure 17. Typical post-impact damage in cross-section at center of impact site (IM6 carbon reinforcement; impacted on top face).

Each sample was cross-sectioned (cut and polished) at four locations and viewed under a microscope, as shown in Appendix B. At the impact site there were many matrix cracks, ply cracks and delaminations, as shown in Figure 17. The matrix cracks were

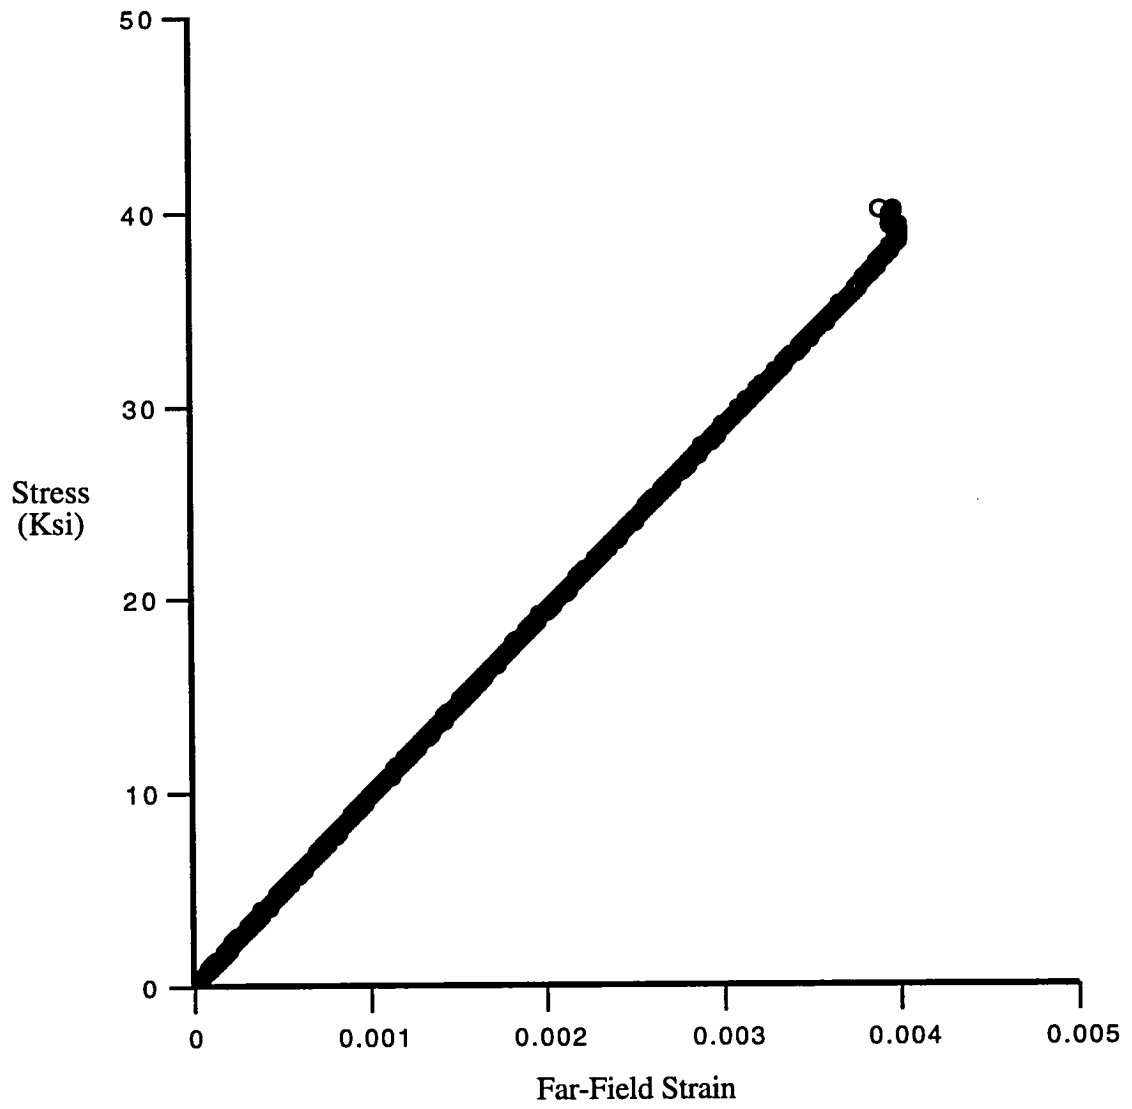
Figure 18. Stress versus far-field strain under static compressive loading (IM6 carbon TTT reinforcement).

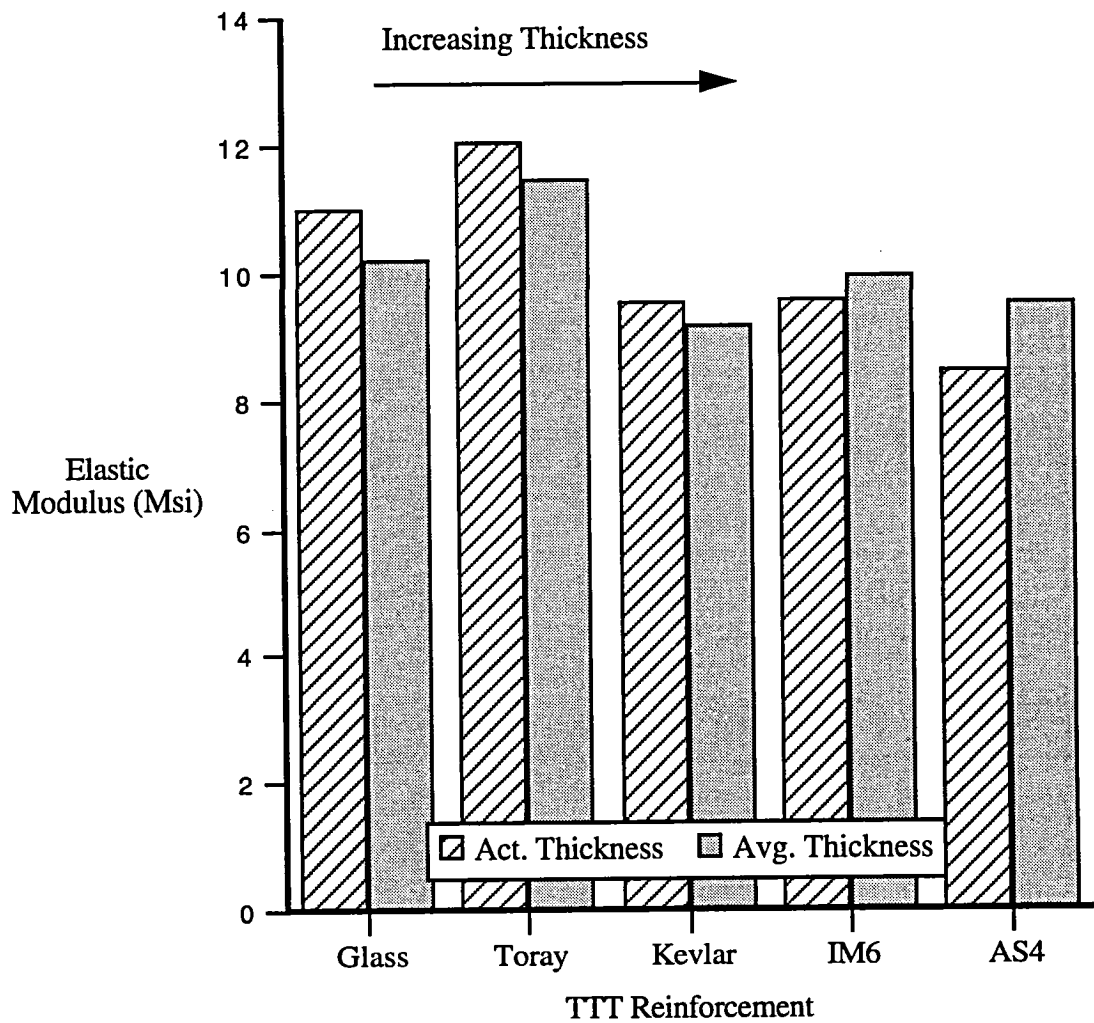
Figure 19. Compressive elastic modulus calculated from actual and average thicknesses.

The average compressive elastic modulus using measured thicknesses was slightly greater than 10 Msi. The Toray carbon sample had an elastic modulus greater than 12 Msi, nearly 19% higher than average. The modulus of the glass sample, about 11 Msi, was also much higher than average. In contrast, the AS4 carbon sample had an elastic modulus of about 8.5 Msi, more than 16% lower than average.

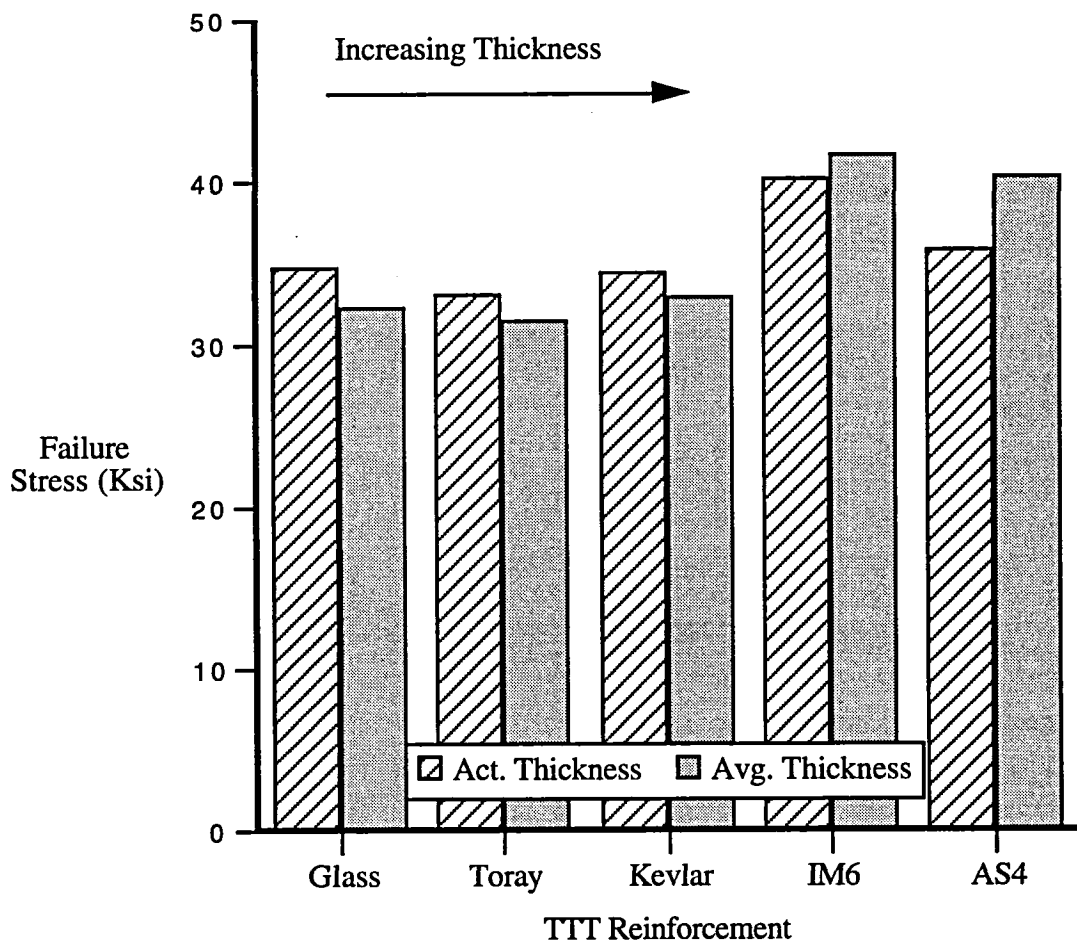
Figure 20. Compressive failure strength calculated from actual and average thicknesses.

In summary, the IM6 carbon sample had the greatest compressive strength and far-field strain. The AS4 carbon sample had the lowest modulus. The Toray carbon and glass samples had the largest compressive modulus and lowest far-field strain. The Kevlar sample had a nearly average strength, maximum compressive strain, and modulus.

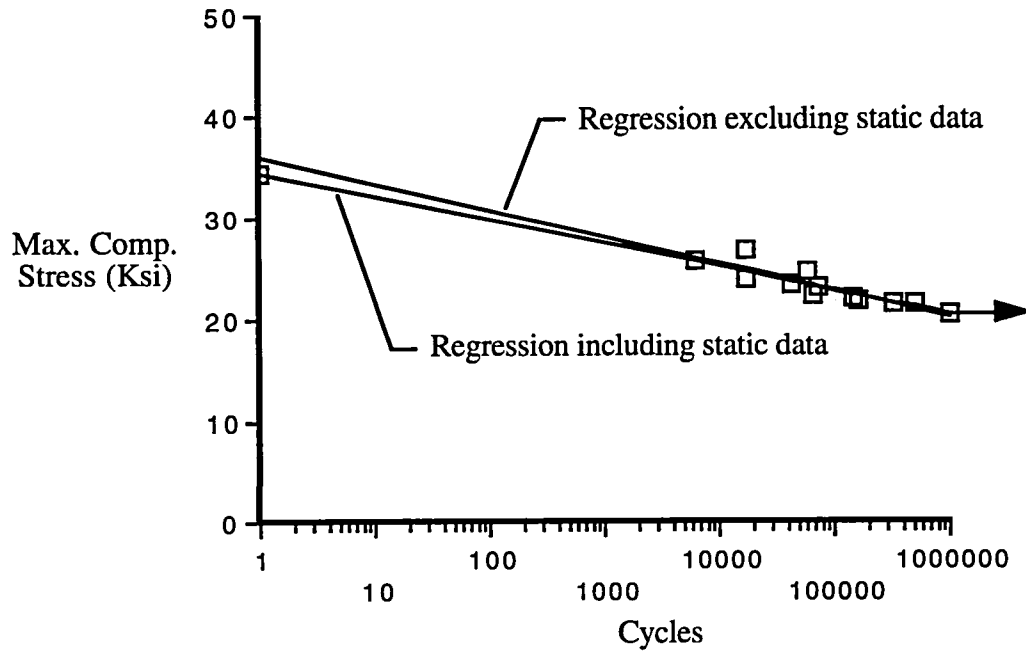
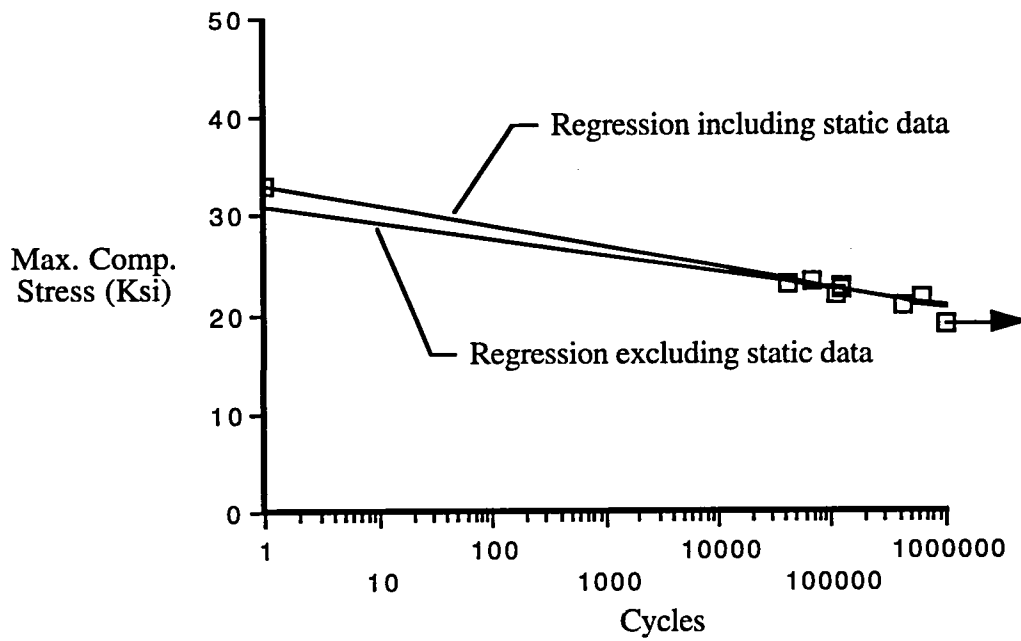
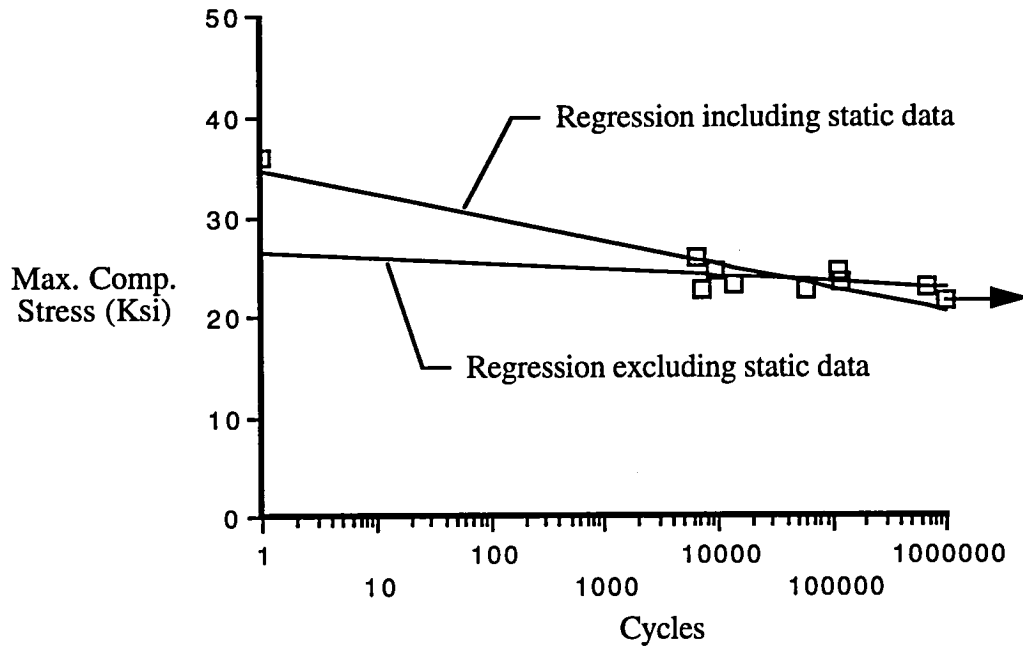
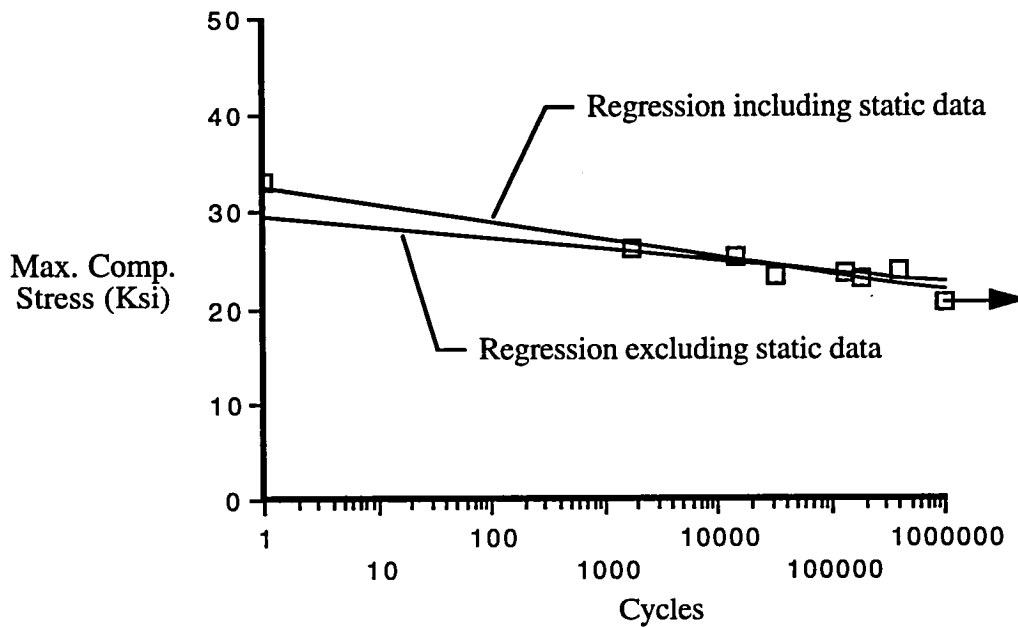
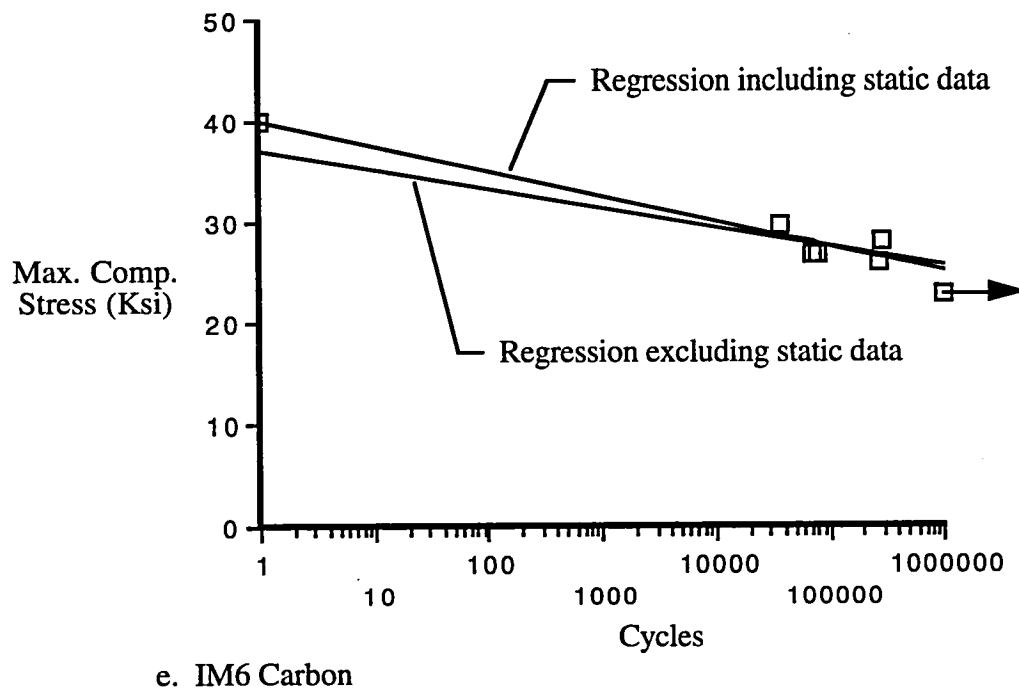
Figure 21. Maximum compressive stress versus cycles for each material.

For each TTT reinforcement the data points did not significantly deviate from the linear regression. However, the static compression strengths did not correspond to the fatigue data. The linear regressions of the fatigue data of the average of all five specimens tested approximate the static strengths to be about 10% lower than the actual strengths. The AS4 carbon material had the largest difference between the actual and approximated strength. A linear regression determined without including the static test approximates the static strength to be about 27% lower than the actual static strength. The difference between actual static strength and strength approximated with long-life fatigue data is

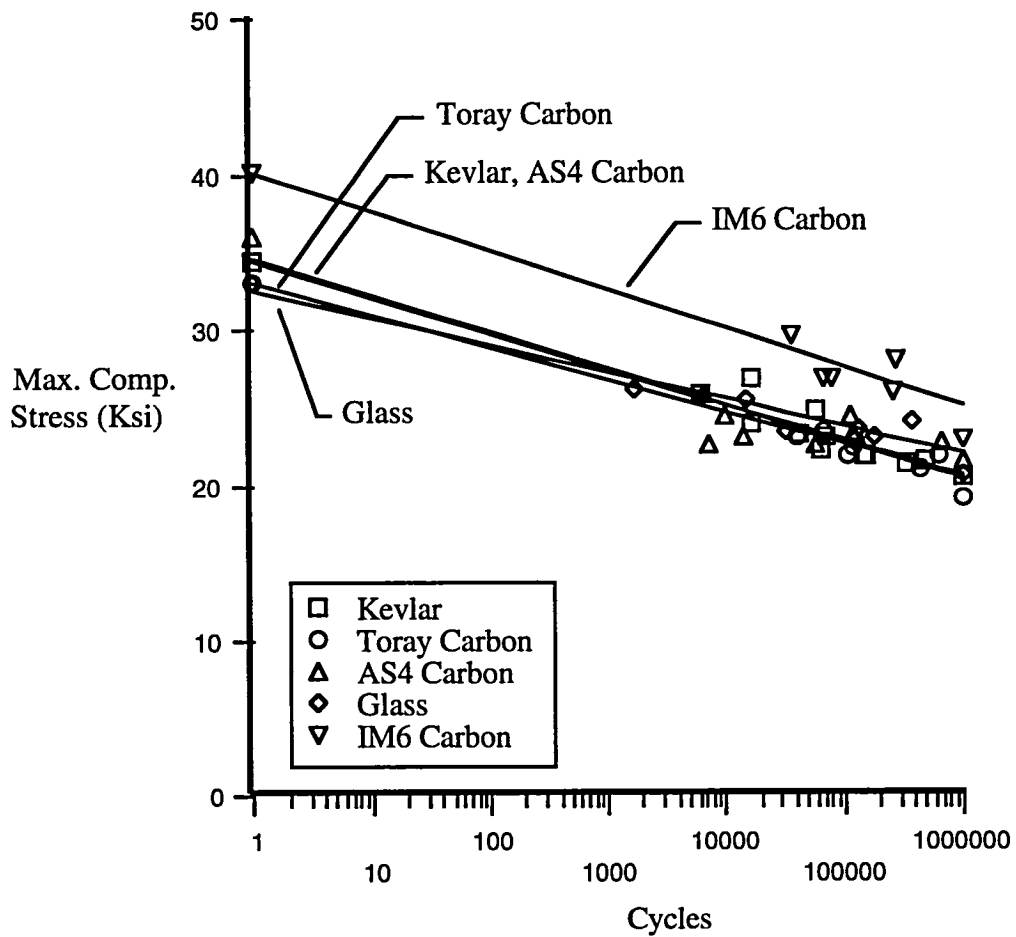
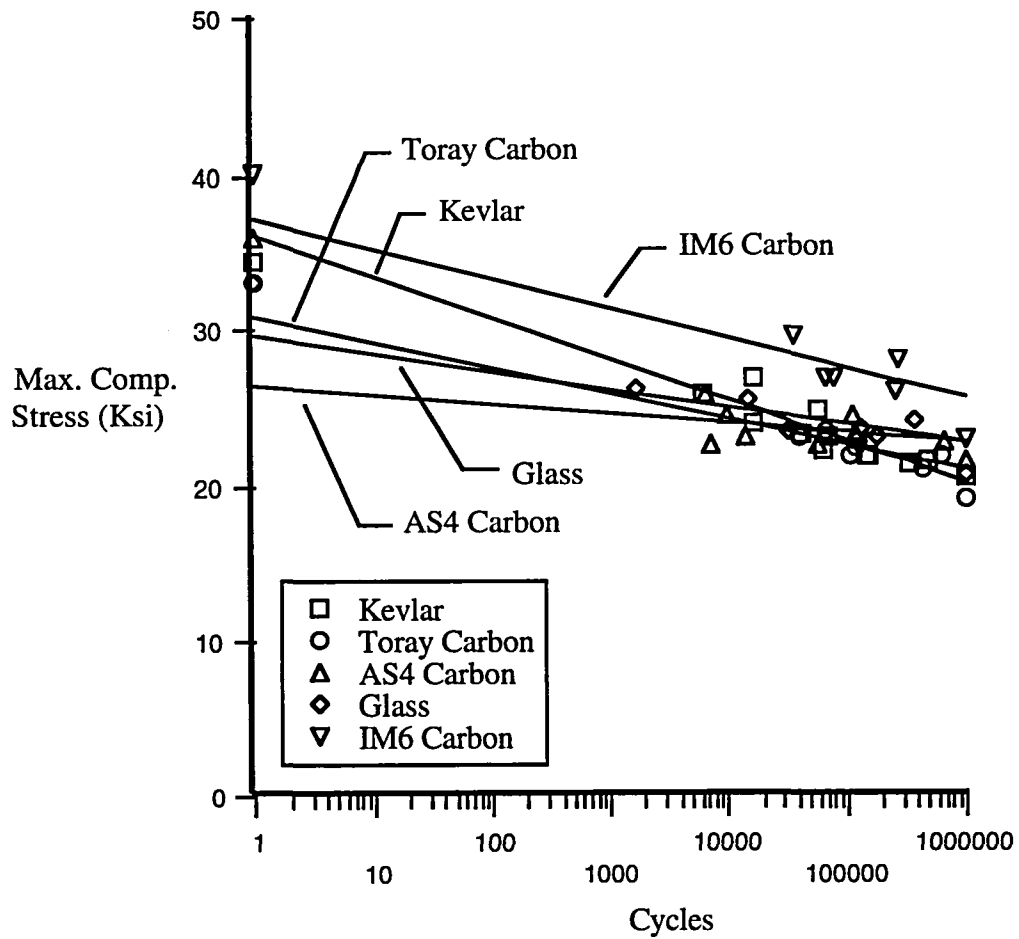
Figure 22. Maximum compressive stress versus cycles for all materials.

The S-N regressions can be more easily compared by contrasting the fatigue stress levels at zero cycles and at one million cycles. Comparisons of the approximated stress levels at zero cycles provides information that can be used merely to compare fatigue response for each material at high stress levels (this is not intended to be a way of predicting life in high stress level fatigue tests). The IM6 carbon and Kevlar regressions had the highest stresses at zero cycles, as shown in Table III. This indicates good fatigue response at high stress levels. The AS4 carbon regression had the lowest zero cycle stress, nearly 18 % below average. This is indicative of poor fatigue response in the short life

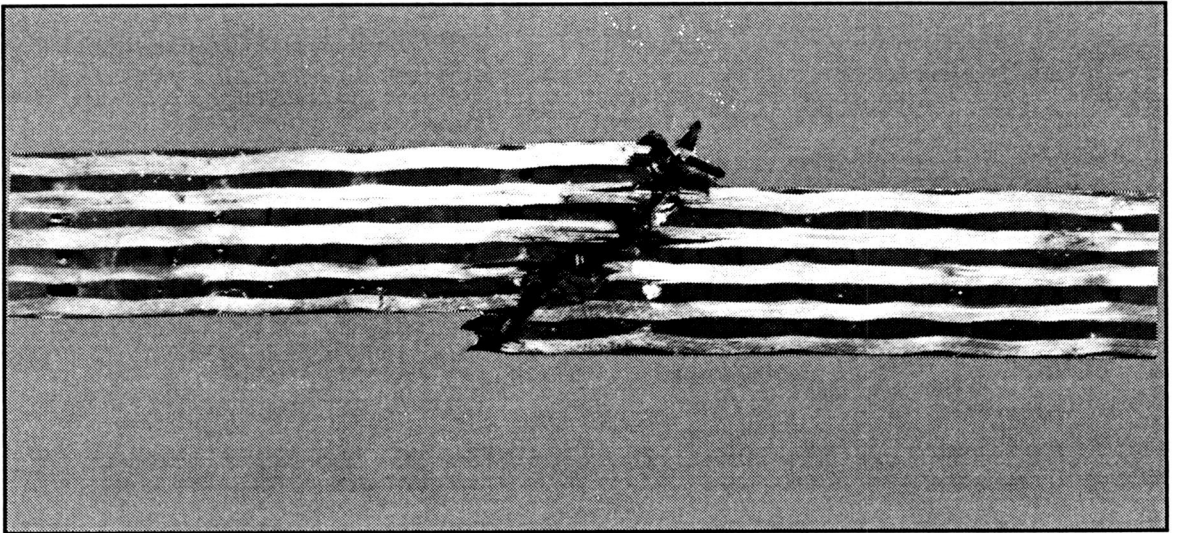
Figure 24. Transverse shear failure mode (Impacted on top face).

Five samples, one from each material group, were sectioned to determine their failure modes, as shown in Appendix B. These samples were previously loaded in fatigue to about 99.9% of life and were sectioned parallel to the loading direction. At the impact site there were many scattered fiber bundle failures, ply cracks and delaminations. There

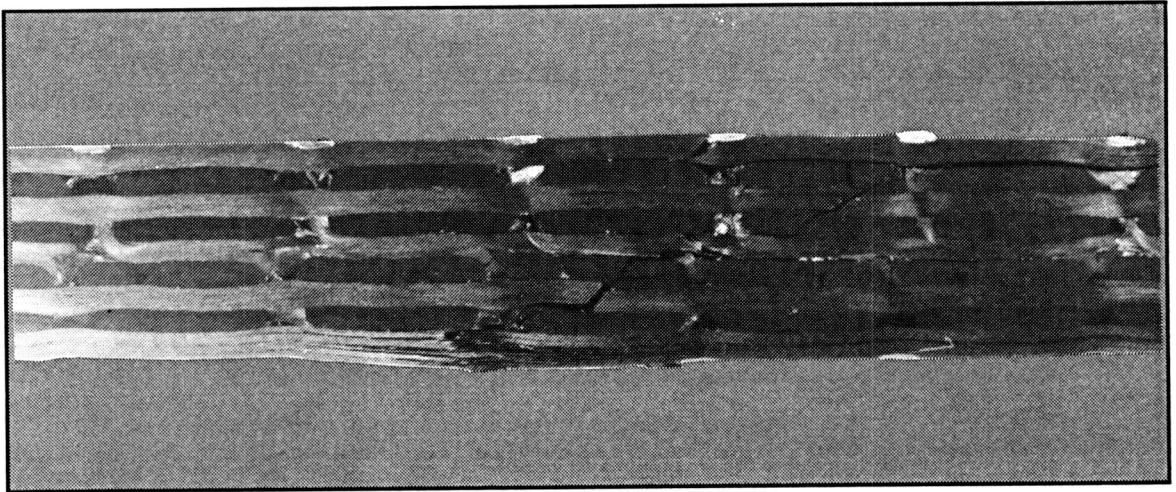
Figure 25. Typical cross-section at center of impact site immediately prior to fatigue failure (Kevlar reinforcement; impacted on top face).

The transverse shear failure modes are assumed to have been caused by the reduction of local stability. There were various differences in the samples that could lead to differences in the number of cycles before reaching critical instability. Local resin-rich zones or voids near the in-plane tows or waviness caused by large TTT fiber bundles could

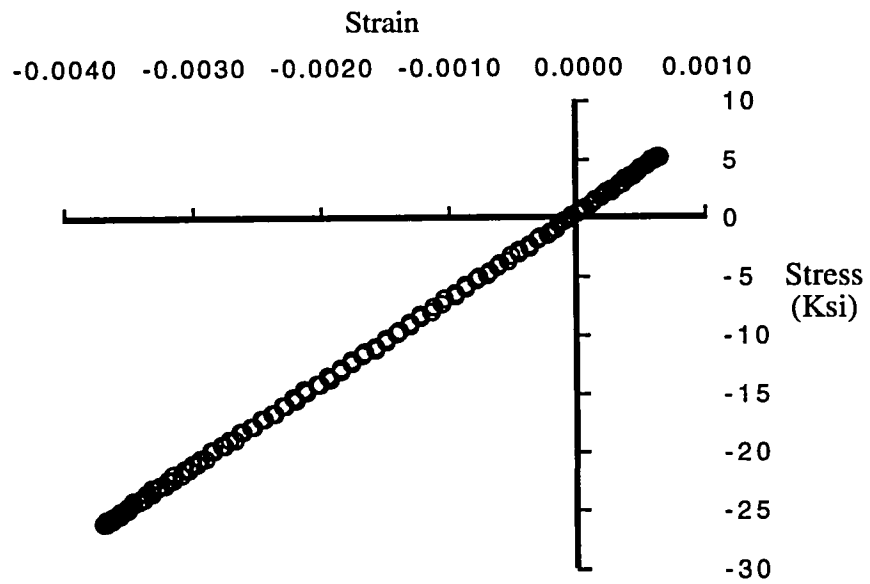
Figure 27. Stress versus strain across front and back faces at impact site for one cycle early in a typical fatigue test (IM6 carbon TTT reinforcement).
